# **Contaminated Land Register Cover Sheet**

**Property Address – 68 Marlpool Drive, Redditch, Worcestershire, B97 4RX**

## ENVIRONMENTAL PROTECTION ACT 1990, SECTION 78B

### RECORD OF DETERMINATION THAT LAND IS CONTAMINATED LAND

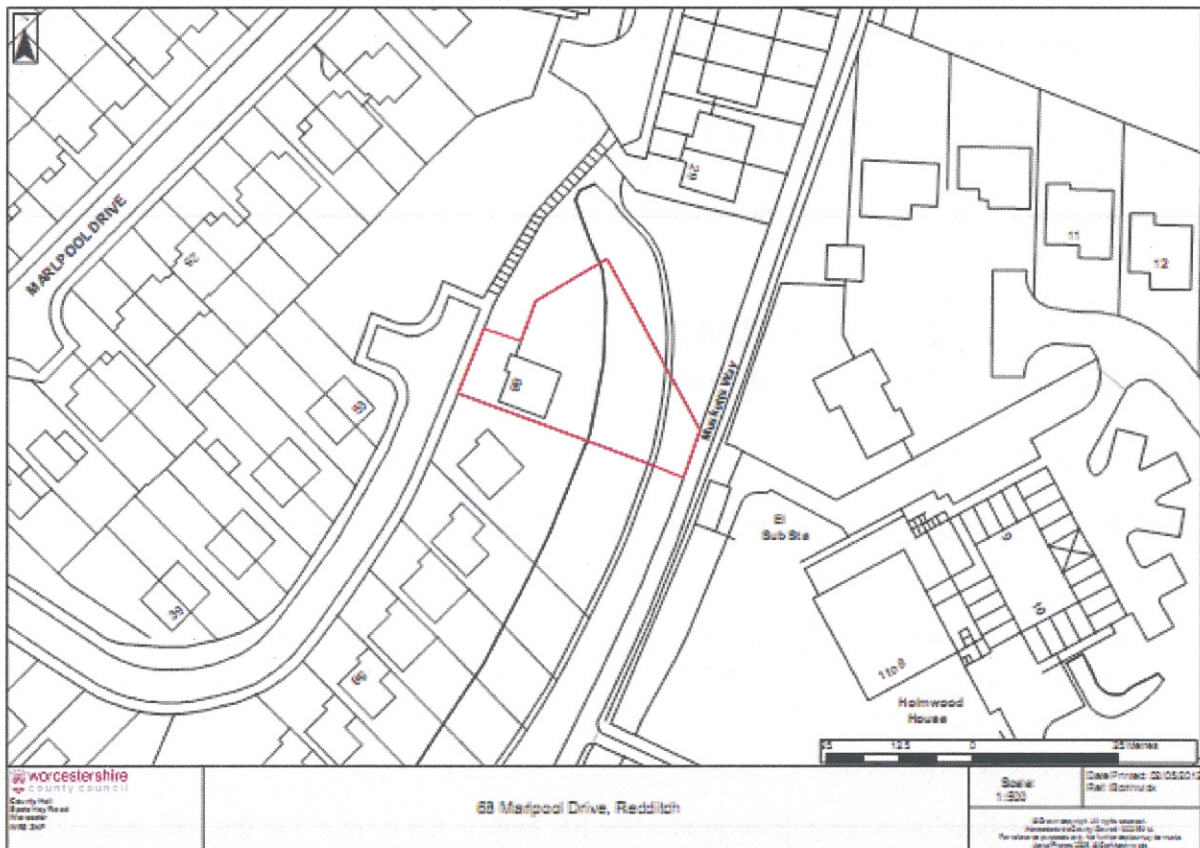
The physical extent of the land determined as Contaminated Land is outlined in red on the map on the following page.

The Site Address: 68 Marlpool Drive, Redditch, Worcestershire, B97 4RX
