# **Contaminated Land Register Cover Sheet**

**Property Address – 37 Marlpool Drive, Redditch, Worcestershire, B97 4RX**

## ENVIRONMENTAL PROTECTION ACT 1990, SECTION 78B

### RECORD OF DETERMINATION THAT LAND IS CONTAMINATED LAND

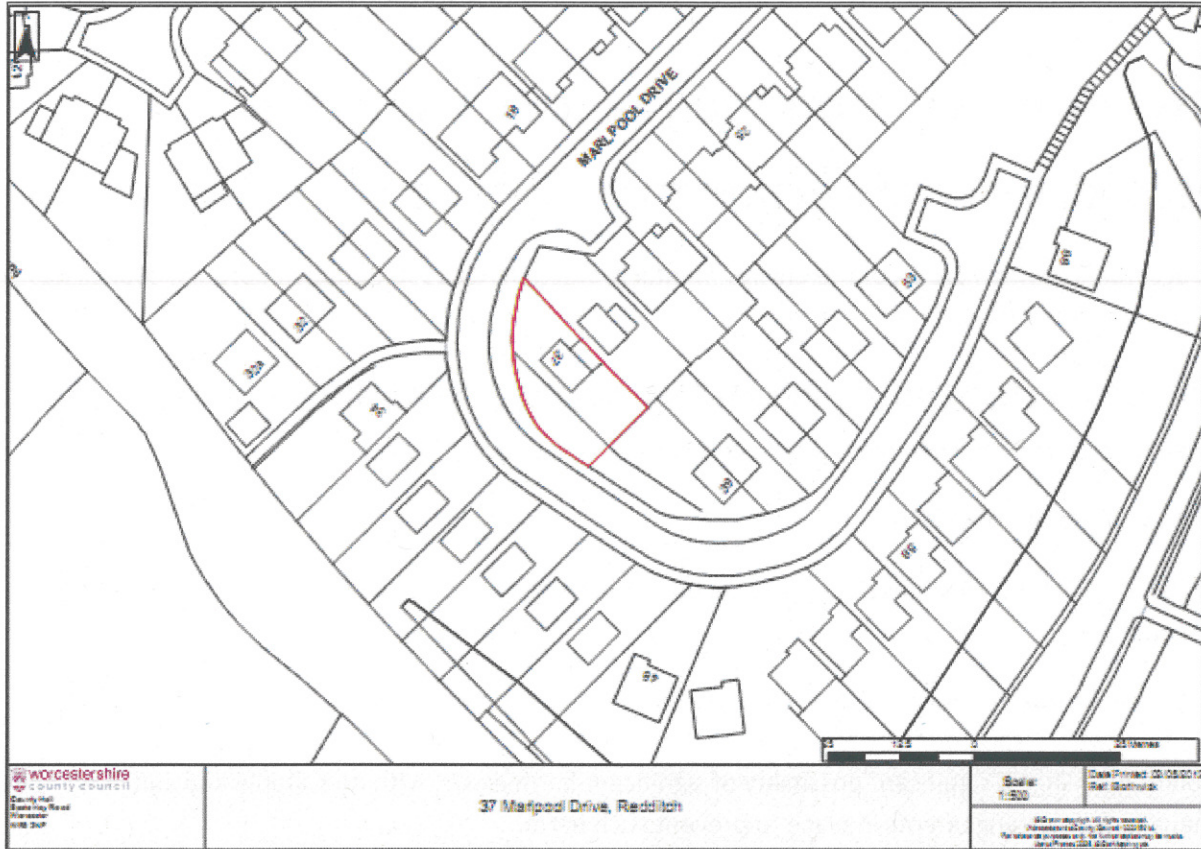
The physical extent of the land determined as Contaminated Land is outlined in red on the map on the following page.

The Site Address: 37 Marlpool Drive, Redditch, Worcestershire, B97 4RX
