Appendix 2 Verification Monitoring Results

Our Ref: GGS192/ILR/47Marlpool/090212

VERIFICATION MONITORING AT 47 MARLPOOL DRIVE, REDDITCH

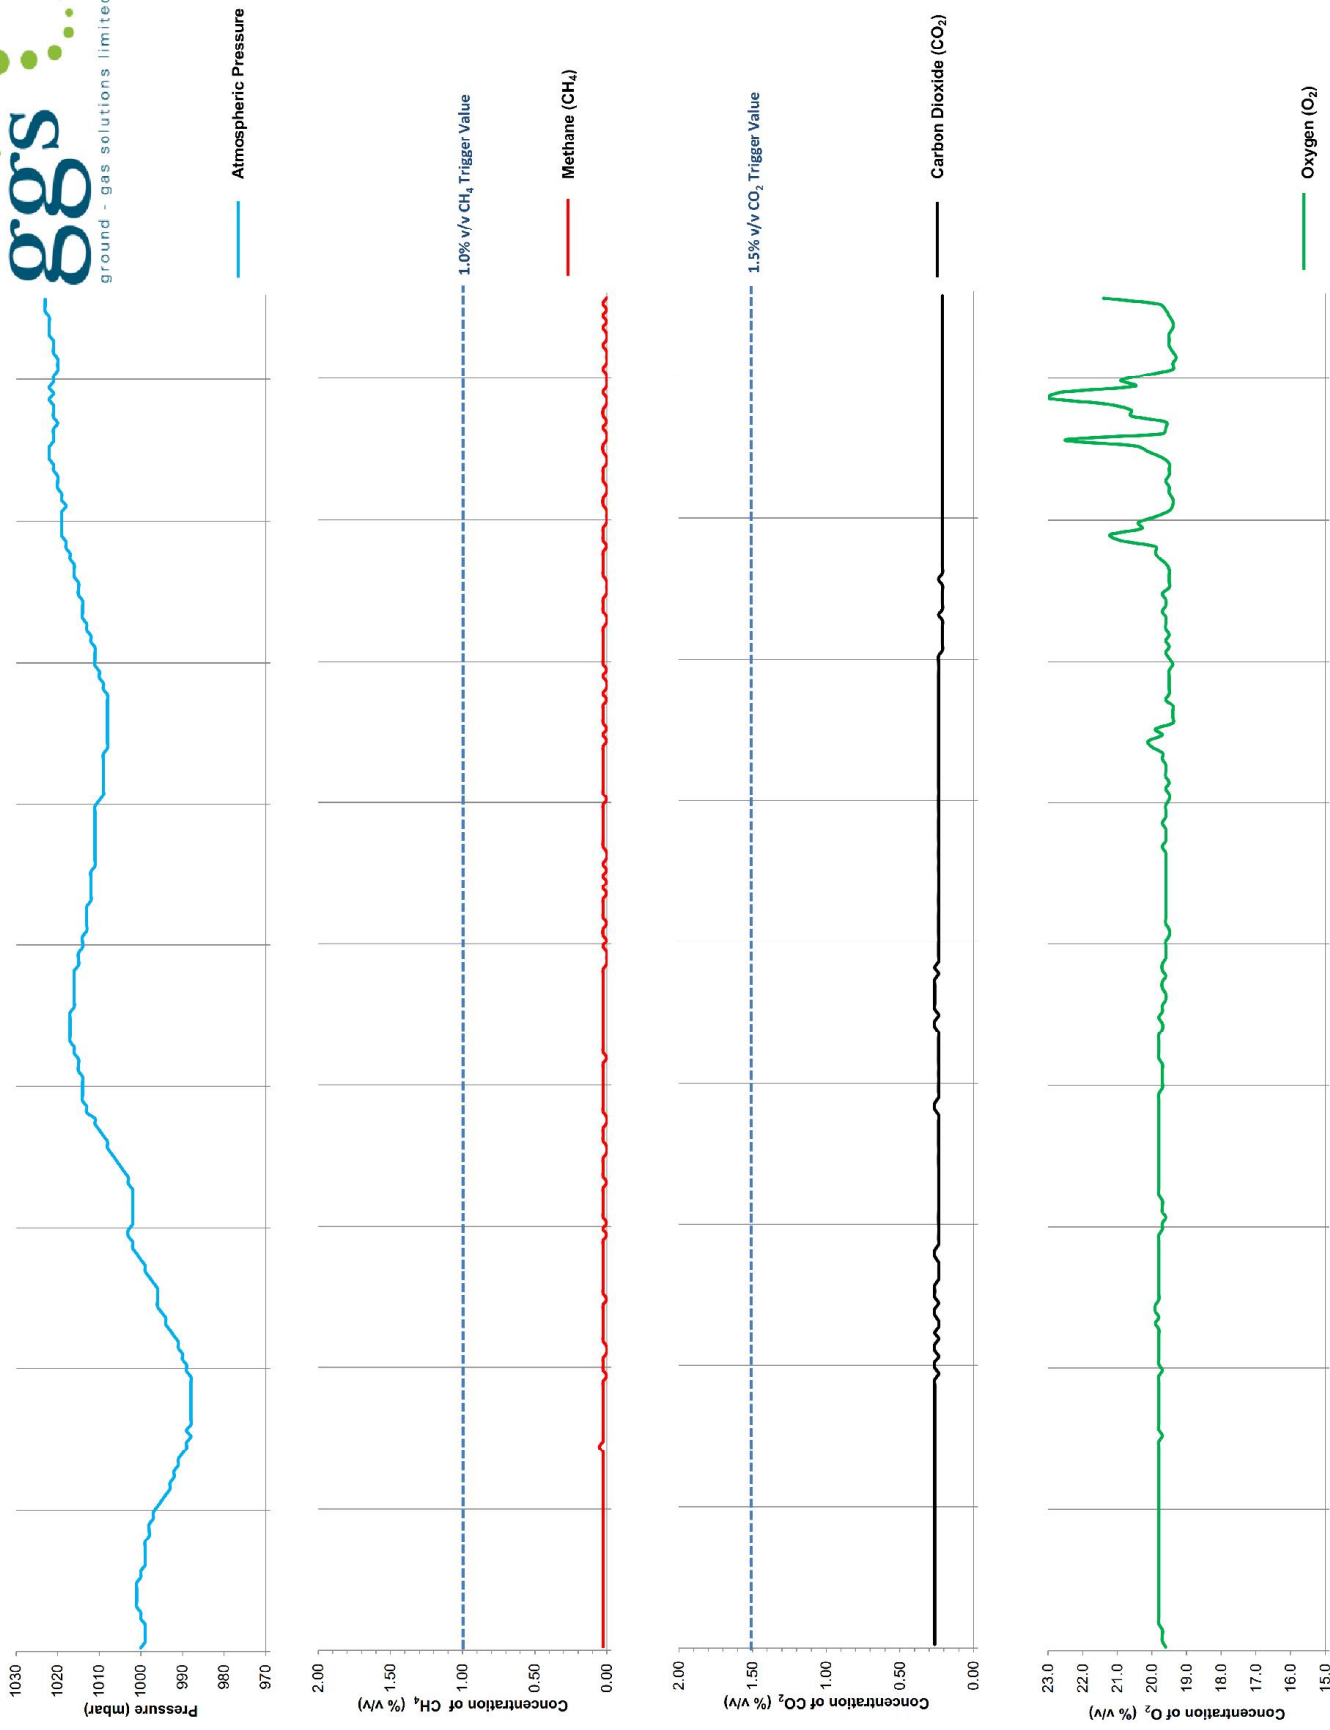
Time Series Graph

2.3 Data analysis involved converting raw data files downloaded from the GasClam[®] device into excel spread sheets. The raw data was plotted as time-series data, showing gas concentrations and atmospheric pressure plotted against time. The Time-series graph is included at the end of the letter report.

Time Series Data:47 Marlpool Drive, Redditch, (external sub-floor monitoring point)

3.3 The methane and carbon dioxide concentrations recorded at No. 47 Marlpool Drive are consistently below the trigger levels set by SKM Enviros.
