**PRESTIGE AIR TECHNOLOGY LTD**  
**RETROSPECTIVE**  
**LOW ENERGY CLEAN AIR BLANKET**  
**O & M MANUAL**  
**DOCUMENTATION**

**REF: 2385**

**RETROSPECTIVE  
POSITIVE PRESSURE SYSTEM  
INSTALLATION REPORT**

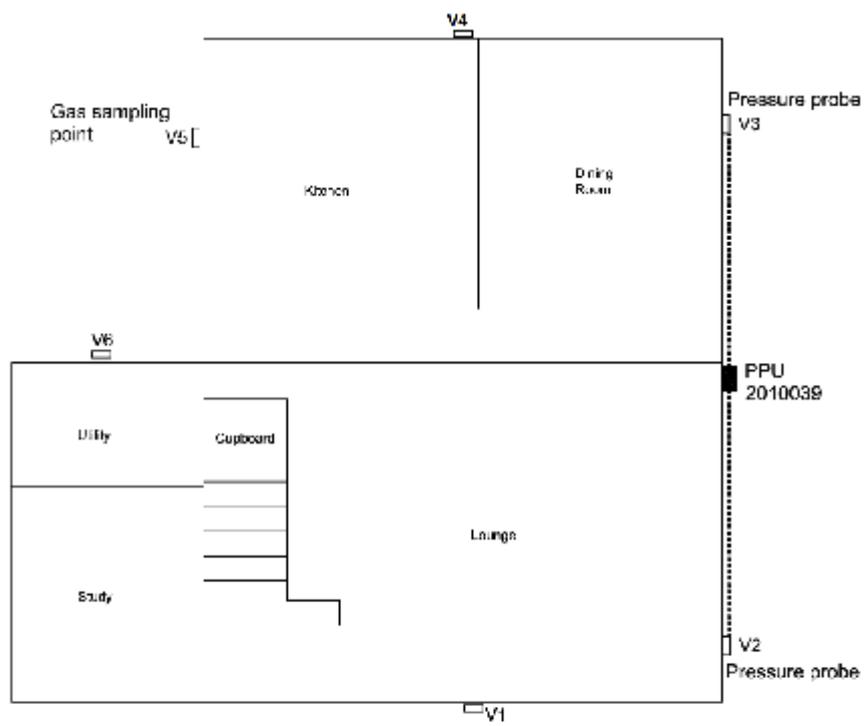
No 58 Marpool Drive

## ZONE OF INFLUENCE RECORD

Location	Levels Recorded
V1	500
V2 Input point	N/A
V3 Input point	N/A
V4	500
V5	800
V6	300

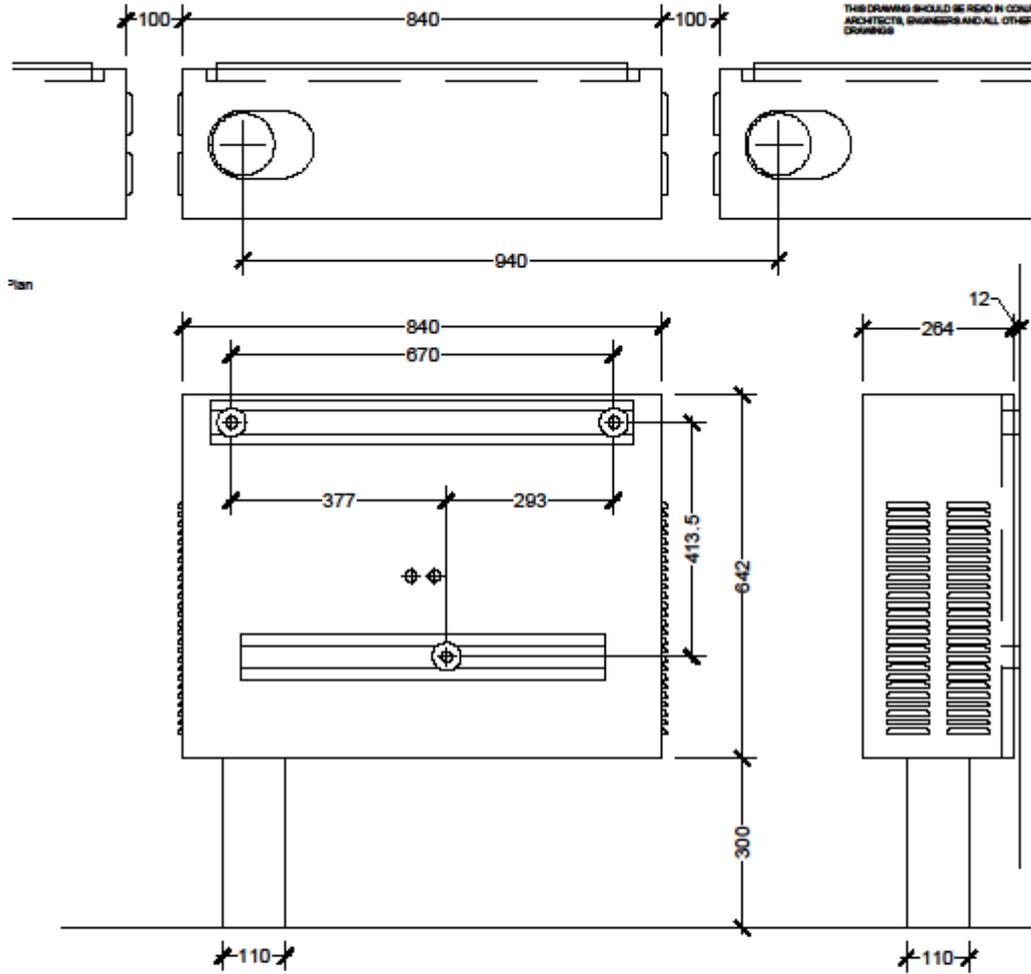
Prestige Clean, Efficient, Healthy Smart, Low, Cleanest Allergy Air 100% HEPA PC 6000 PPHW Pm 100% HEPA
<b>PRESTIGE</b>		
Standard detail Component Elevations Low energy P.P.U Elevations Prestige Air-Technology Ltd		
100 October 2011	100.2 1.10	100 JK
For information		100
5719 AA(57) 012		PC

Rear Elevation

Side Elevation
